**Flood Control Project Maintenance  
Levee Inspections**

## Maintenance Issue Types Only, Levee Inspection Report By Mile - Spring 2019

### Marysville Levee Commission

Waterway	Bank	Unit Miles	Inspection Start/End	Inspector
Unit No. 01 Simmerly Slough	Left	3.23	04/17/2019 04/17/2019	Sterling York

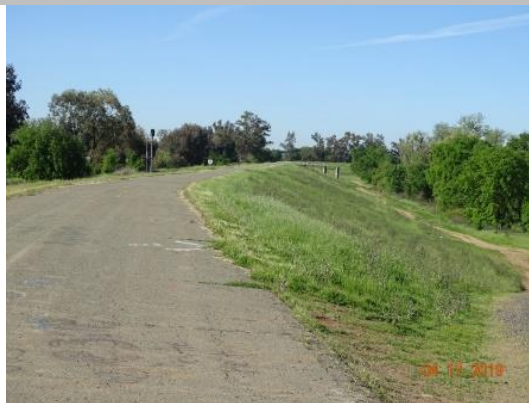
Photo 1 of 1 : SP\_2019\_NA0004\_104\_10\_20190418\_00018.jpg

LM Start	0.03	Rating **	A	Issue No.	10
LM End	3.16	Issue Type +	Ma	Location *	WS
Category	Earthen Levee			GPS Latitude/Longitude	
				Start	End
Item	Vegetation			39.149888 °	39.164064 °
				-121.600981 °	-121.560828 °
DWR ID	DWR_NA0004_01_s_2019_10				
Comment Code					
V1 : Control annual grass and weeds on the levee slopes and easements.					
Inspector Comment					
The annual vegetation is well maintained, Spring 2019.

View looking downstream waterside at the well maintained vegetation, Spring 2019.

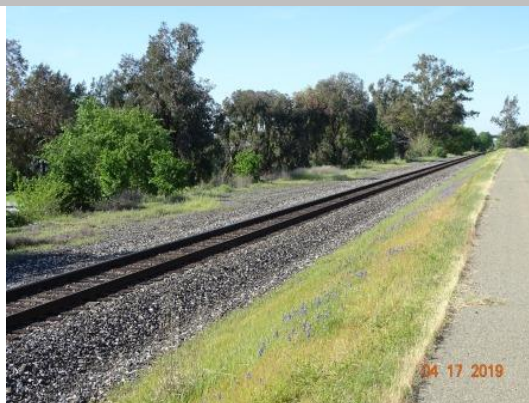
Photo 1 of 1 : SP\_2019\_NA0004\_104\_9\_20190418\_00016.jpg

LM Start	0.03	Rating **	A	Issue No.	9
LM End	3.16	Issue Type +	Ma	Location *	LS
Category	Earthen Levee			GPS Latitude/Longitude	
				Start	End
Item	Vegetation			39.149888 °	39.164060 °
				-121.600981 °	-121.560814 °
DWR ID	DWR_NA0004_01_s_2019_9				
Comment Code					
V1 : Control annual grass and weeds on the levee slopes and easements.					
Inspector Comment					
The annual vegetation is well maintained, Spring 2019.

View looking downstream landside at the well maintained vegetation, Spring 2019.

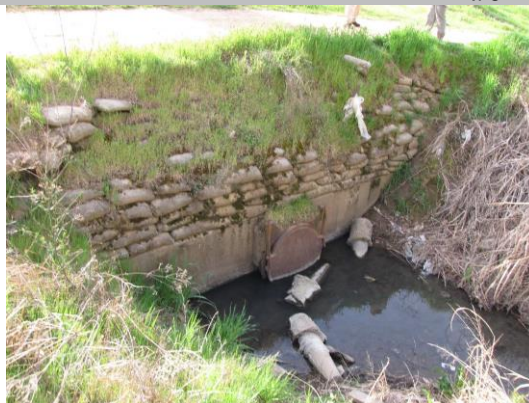
Photo 1 of 3 : UCIP\_SP\_2019\_52792\_69744.jpg

Comment Code					
Inspector Comment					
FS_ID:52792 DS_ID:19090 EP_NO: N/A Repair Type: No Action Needed Crossing Status: Found UCIP Comments: FIELD_STRUCT_DESC: 36-inch corrugated metal drainage pipe through levee, 27 feet below crown. Flap gate and concrete "U" headwall on waterside (WS) end. Slide gate in 48-inch corrugated metal riser on WS slope of pipe. Steel walkway to control gate. Outfall drains from Ellis Lake. Concrete headwall at both toes. Concrete base under riser units. Steel riser unit and slide gate added under Permit No. 4041, 1962-Marysville Levee Commission. [Additional Reference(s): DWR Levee Logs, 1993 and 2005. USACE Sacramento O&M Manual Unit No. 147, August 1955, (Station 8+48)] FS Date: 3/14/2013

View of outlet located on waterward side under toe road.

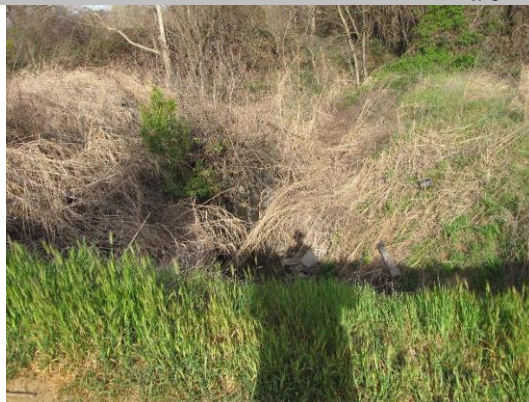
Photo 2 of 3 : UCIP\_SP\_2019\_52792\_69743.jpg

View of waterward side from toe road.

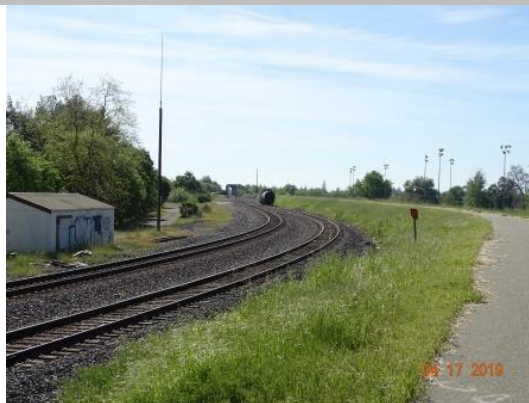
Photo 1 of 1 : SP\_2019\_NA0004\_105\_3\_20190418\_00011.jpg

LM Start	0.00	Rating **	M	Issue No.	3
LM End	1.23	Issue Type +	Ma	Location *	LS
Category	Earthen Levee			GPS Latitude/Longitude	
				Start	End
Item	Vegetation			39.149556 °	39.134754 °
				-121.601108 °	-121.594039 °
DWR ID	DWR_NA0004_02_s_2019_3				
Comment Code					
V1 : Control annual grass and weeds on the levee slopes and easements.					
Inspector Comment					
The annual vegetation needs to be mowed on the landside, Spring 2019.

View looking downstream landside at the annual vegetation that needs to be maintained, Spring 2019.

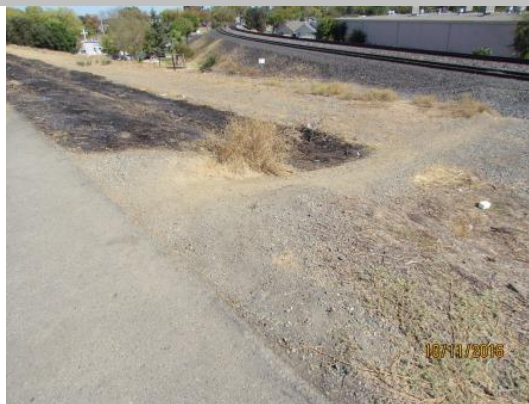
Photo 1 of 1 : SP\_2019\_NA0004\_105\_8\_20190305\_00001.jpg

LM Start	0.22	Rating **	A/W	Issue No.	8
LM End	0.22	Issue Type +	Ma	Location *	LS
Category	Earthen Levee			GPS Latitude/Longitude	
				Start	End
Item	Slope Stability			39.146352 °	39.146352 °
				-121.600724 °	-121.600724 °
DWR ID	DWR_NA0004_02_f_2016_8				
Comment Code					
S2 : Repair the levee slope damaged by foot traffic and prevent access where possible.					
Inspector Comment					
Foot path depression in the landside levee slope shows no sign of erosion and the slope is stable, Spring 2019.

View of foot path depression in the landside levee slope.

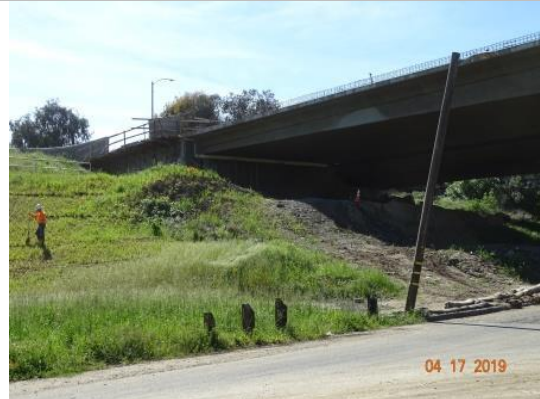
Photo 1 of 1 : SP\_2019\_NA0004\_105\_5\_20190418\_00010.jpg

LM Start	0.72	Rating **	A	Issue No.	5
LM End	0.72	Issue Type +	Ma	Location *	CR
Category	Earthen Levee			GPS Latitude/Longitude	
				Start	End
Item	Crown Surface / Depressions / Rutting			39.139958 °	39.139958 °
				-121.601648 °	-121.601648 °
DWR ID	DWR_NA0004_02_s_2019_5				
Comment Code					
C1 : Add appropriate material and re-grade the levee to bring the crown above the design elevation.					
Inspector Comment					
There is ongoing construction at the Fifth Street Bridge, Spring 2019.

View looking at the Fifth Street Bridge abutment waterside on the left bank of the Feather River, completion is estimated for the end of 2019.

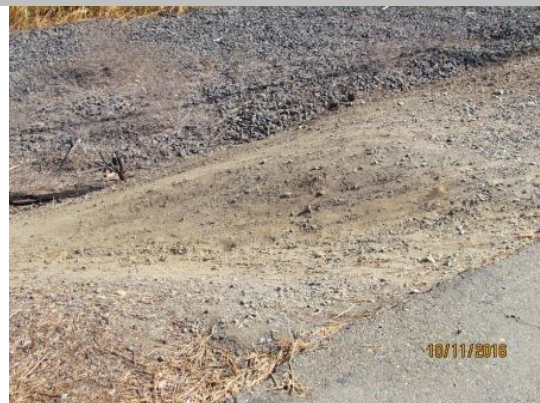
Photo 1 of 1 : SP\_2019\_NA0004\_105\_13\_20190305\_00002.jpg

LM Start	0.82	Rating **	M	Issue No.	13
LM End	0.82	Issue Type +	Ma	Location *	LS
Category	Earthen Levee			GPS Latitude/Longitude	
				Start	End
Item	Slope Stability			39.138827 °	39.138827 °
				-121.599530 °	-121.599530 °
DWR ID	DWR_NA0004_02_f_2016_13				
Comment Code					
S2 : Repair the levee slope damaged by foot traffic and prevent access where possible.					
Inspector Comment					
Foot path depression in the landside levee slope needs to be repaired.

View of foot path depression in the landside levee slope.

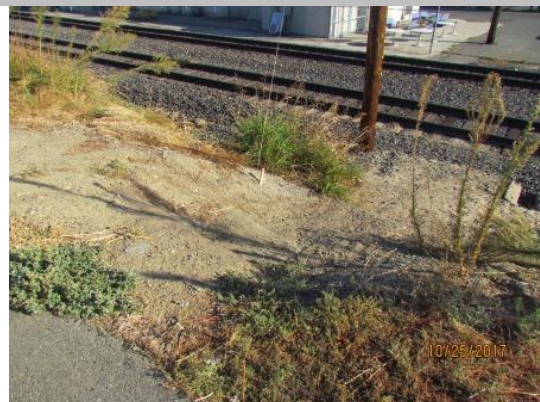
Photo 1 of 1 : SP\_2019\_NA0004\_105\_14\_20190305\_00003.jpg

LM Start	0.85	Rating **	M	Issue No.	14
LM End	0.85	Issue Type +	Ma	Location *	LS
Category	Earthen Levee			GPS Latitude/Longitude	
				Start	End
Item	Slope Stability			39.138463 °	39.138463 °
				-121.599168 °	-121.599168 °
DWR ID	DWR_NA0004_02_f_2016_14				
Comment Code					
S2 : Repair the levee slope damaged by foot traffic and prevent access where possible.					
Inspector Comment					
Remove steps that are cut into levee slope.

View of steps for foot path in the landside levee slope.

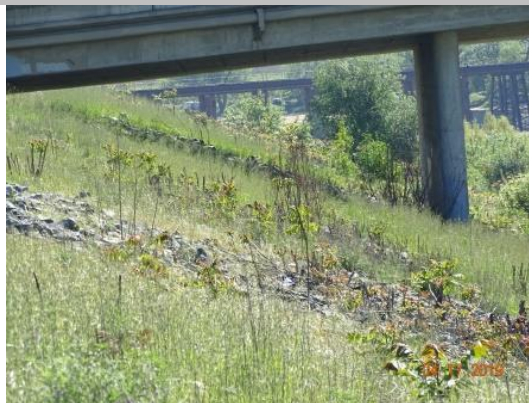
Photo 1 of 1 : SP\_2019\_NA0004\_106\_16\_20190418\_00046.jpg

LM Start	0.13	Rating **	A	Issue No.	16
LM End	0.40	Issue Type +	Ma	Location *	WS
Category	Earthen Levee			GPS Latitude/Longitude	
				Start	End
Item	Trim / Thin Trees			39.135153 °	39.135327 °
				-121.591509 °	-121.586508 °
DWR ID	DWR_NA0004_03_s_2019_16				
Comment Code					
T3 : Trim and thin trees to allow visibility of the ground and room to flood fight.					
Inspector Comment					
Continue to trim and remove the starter trees in this location, Spring 2019.

View looking upstream waterside where intrusive starter trees have been trimmed and sprayed, Spring 2019.

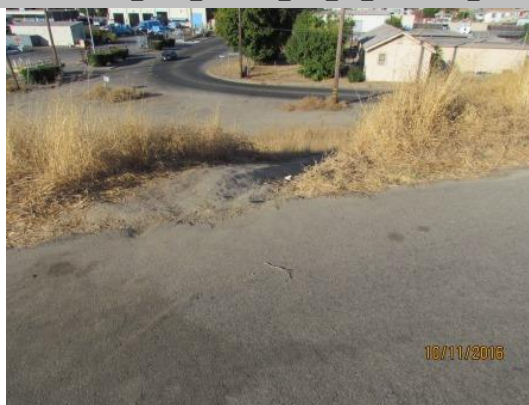
Photo 1 of 1 : SP\_2019\_NA0004\_106\_30\_20190305\_00006.jpg

LM Start	1.00	Rating **	M	Issue No.	30
LM End	1.00	Issue Type +	Ma	Location *	LS
Category	Earthen Levee			GPS Latitude/Longitude	
				Start	End
Item	Slope Stability			39.142167 °	39.142167 °
				-121.582817 °	-121.582817 °
DWR ID	DWR_NA0004_03_f_2016_30				
Comment Code					
S2 : Repair the levee slope damaged by foot traffic and prevent access where possible.					
Inspector Comment					
Path cut in by foot traffic on the landside slope needs to be repaired.

View of path cut in by foot traffic on the landside slope.

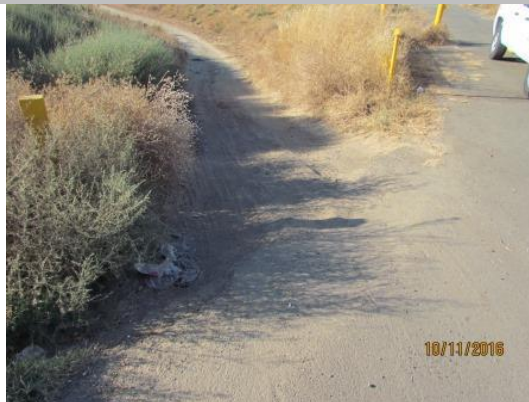
Photo 1 of 1 : SP\_2019\_NA0004\_106\_32\_20190305\_00007.jpg

LM Start	1.16	Rating **	A/W	Issue No.	32
LM End	1.16	Issue Type +	Ma	Location *	WS
Category	Earthen Levee			GPS Latitude/Longitude	
				Start	End
Item	Slope Stability			39.144392 °	39.144392 °
				-121.582930 °	-121.582930 °
DWR ID	DWR_NA0004_03_f_2016_32				
Comment Code					
S3 : Repair the levee slope damaged by vehicle traffic and prevent access where possible.					
Inspector Comment					
Ruts cut in by vehicle traffic on the landside slope show no sign of erosion, slope is stable, Spring 2019.

View of ruts cut in by vehicle traffic on the waterside slope.

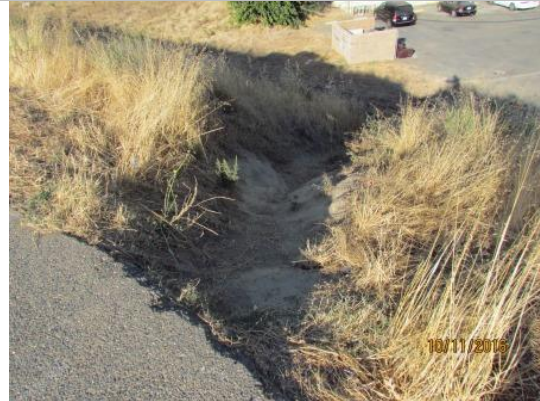
Photo 1 of 1 : SP\_2019\_NA0004\_106\_33\_20190305\_00008.jpg

LM Start	1.28	Rating **	M	Issue No.	33
LM End	1.28	Issue Type +	Ma	Location *	LS
Category	Earthen Levee			GPS Latitude/Longitude	
				Start	End
Item	Slope Stability			39.145723 °	39.145723 °
				-121.581323 °	-121.581323 °
DWR ID	DWR_NA0004_03_f_2016_33				
Comment Code					
S2 : Repair the levee slope damaged by foot traffic and prevent access where possible.					
Inspector Comment					
Path cut in by foot traffic on the landside slope needs to be repaired.

View of path cut in by foot traffic on the landside slope that needs repaired.

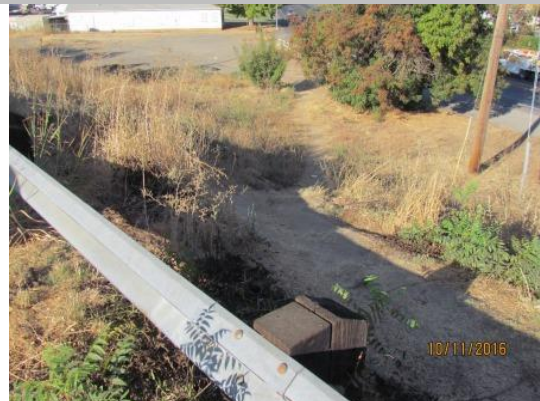
Photo 1 of 1 : SP\_2019\_NA0004\_106\_18\_20190305\_00003.jpg

LM Start	1.61	Rating **	M	Issue No.	18
LM End	1.61	Issue Type +	Ma	Location *	LS
Category	Earthen Levee			GPS Latitude/Longitude	
				Start	End
Item	Slope Stability			39.149098 °	39.149098 °
				-121.577162 °	-121.577162 °
DWR ID	DWR_NA0004_03_f_2016_18				
Comment Code					
S2 : Repair the levee slope damaged by foot traffic and prevent access where possible.					
Inspector Comment					
Erosion from foot traffic should be repaired.

View of foot path that has cut into landside levee slope.

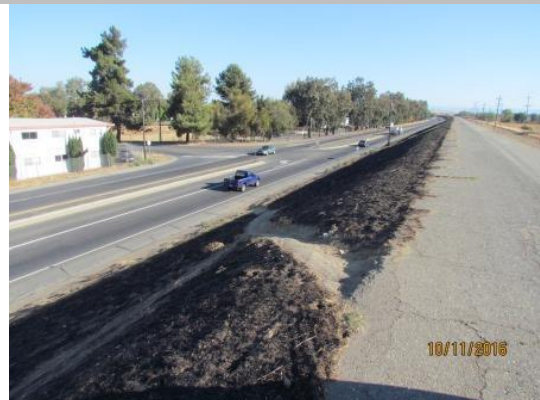
Photo 1 of 1 : SP\_2019\_NA0004\_106\_39\_20190305\_00011.jpg

LM Start	2.15	Rating **	M	Issue No.	39
LM End	2.15	Issue Type +	Ma	Location *	LS
Category	Earthen Levee			GPS Latitude/Longitude	
				Start	End
Item	Slope Stability			39.154440 °	39.154440 °
				-121.569839 °	-121.569839 °
DWR ID	DWR_NA0004_03_f_2016_39				
Comment Code					
S2 : Repair the levee slope damaged by foot traffic and prevent access where possible.					
Inspector Comment					
Erosion from foot traffic should be repaired.

View looking upstream of foot path that has cut into the landside levee slope.

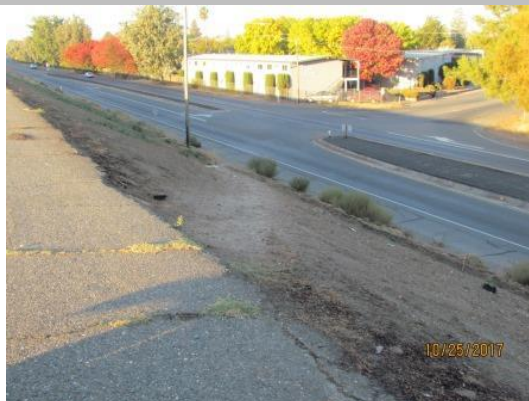
Photo 1 of 1 : SP\_2019\_NA0004\_106\_40\_20190305\_00012.jpg

LM Start	2.21	Rating **	A/W	Issue No.	40
LM End	2.21	Issue Type +	Ma	Location *	LS
Category	Earthen Levee			GPS Latitude/Longitude	
				Start	End
Item	Slope Stability			39.155076 °	39.155076 °
				-121.568970 °	-121.568970 °
DWR ID	DWR_NA0004_03_f_2016_40				
Comment Code					
S2 : Repair the levee slope damaged by foot traffic and prevent access where possible.					
Inspector Comment					
Ruts cut in by foot traffic on the landside slope show no sign of erosion, slope is stable, Spring 2019.

View looking downstream landside of foot path that is cut into the landside levee slope.

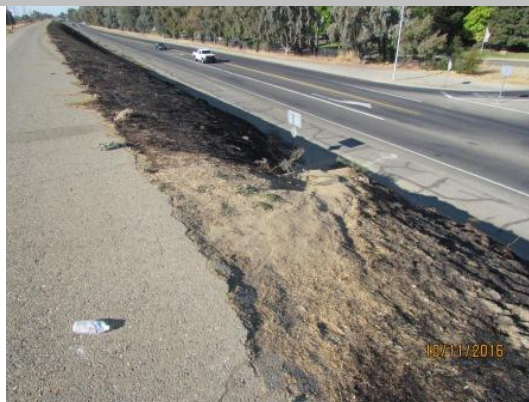
Photo 1 of 1 : SP\_2019\_NA0004\_106\_41\_20190305\_00013.jpg

LM Start	2.55	Rating **	M	Issue No.	41
LM End	2.55	Issue Type +	Ma	Location *	LS
Category	Earthen Levee			GPS Latitude/Longitude	
				Start	End
Item	Slope Stability			39.158509 °	39.158509 °
				-121.564423 °	-121.564423 °
DWR ID	DWR_NA0004_03_f_2016_41				
Comment Code					
S2 : Repair the levee slope damaged by foot traffic and prevent access where possible.					
Inspector Comment					
Erosion from foot traffic should be repaired.

View looking downstream of foot path that has cut into the landside slope.

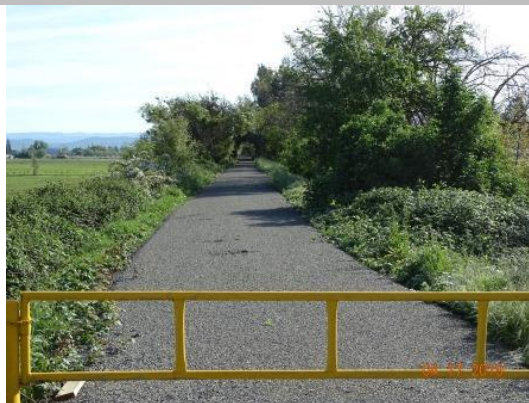
Photo 1 of 1 : SP\_2019\_NA0004\_106\_17\_20190418\_00043.jpg

LM Start	4.84	Rating **	A	Issue No.	17
LM End	6.78	Issue Type +	Ma	Location *	CR
Category	Earthen Levee			GPS Latitude/Longitude	
				Start	End
Item	Crown Surface / Depressions / Rutting			39.185400 °	39.202392 °
				-121.540019 °	-121.511184 °
DWR ID	DWR_NA0004_03_s_2019_17				
Comment Code					
C3 : Add appropriate gravel or road base. Grade and compact.					
Inspector Comment					
This section is for evacuation and patrol only. Crown surface has been rocked and low limbs have been trimmed.

View looking upstream crown of the section of levee that is only a patrol road and used in the case of emergency for evacuation access.
